TEST REPORT

Report No. : BJ-R230605104A-01-EN
Test Item : Drop test
Client : Shenzhen Recoda Technologies Limited
Address : 3F, Sixth Plant, Tangzhong Industrial Park, Hengnan Road, Gushu, Xixiang, Baoan District, Shenzhen City, Guangdong, China

| Sample Name | body worn camera |
| Sample Model | M530 |

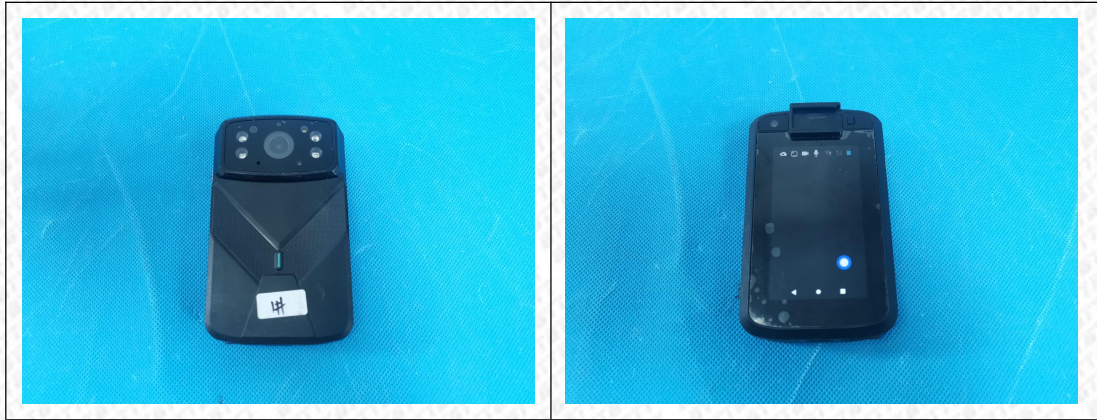
Before test

| Sample Description | Sample appearance is good |

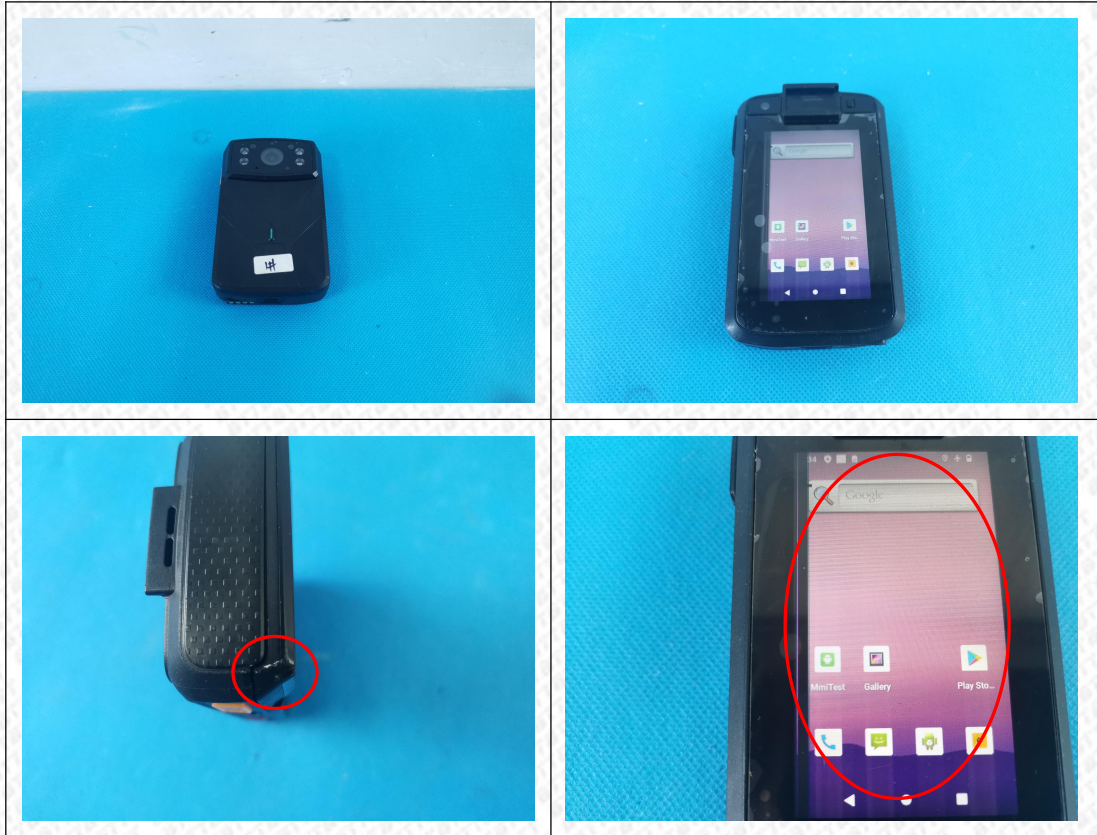
After test

| Test Items | Test Results | | |
|---|---|--|---|
| Drop test | The first time of the face drops, the battery cover and battery fall off. | The first time of the edge drops, the gap on the surface becomes larger. | The first time of the corner drops, the display screen appears blurred. |
